ANNUAL REPORT FOR 2011

Middle Fork Creek Site I Mitigation Site
Madison County
TIP No. R-2518A

Prepared By:
Natural Environment Unit & Roadside Environmental Unit
North Carolina Department of Transportation
December 2011

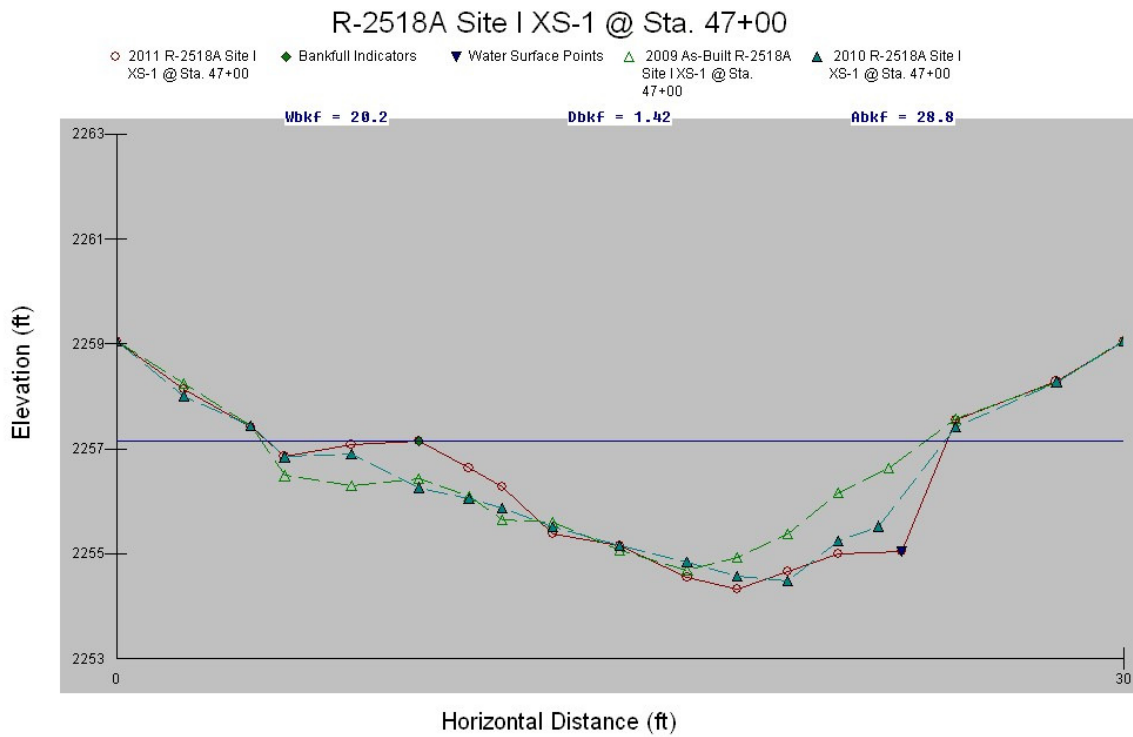
Site I: Cross-Section #1 (Pool) Abbreviated Morphological Summary					
	2010	2011	2012	2013	2014
Bankfull Cross Sectional Area (ft ²)	34.89	42.04			
Maximum Bankfull Depth (ft.)	2.93	2.89			
Bankfull Mean Depth (ft.)	1.66	1.67			
Bankfull Width (ft.)	20.97	25.14

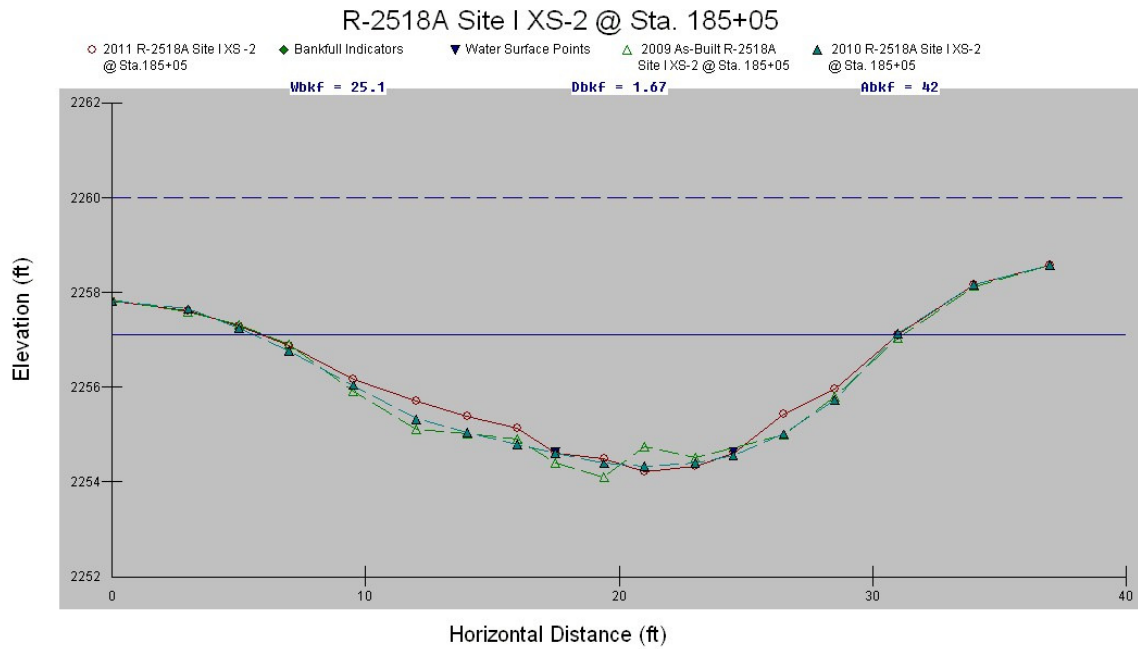
Site I: Cross-Section #2 (Riffle) Abbreviated Morphological Summary					
	2010	2011	2012	2013	2014
Bankfull Cross Sectional Area (ft ²)	46.76	42.04			
Maximum Bankfull Depth (ft.)	2.8	2.89			
Width of the Floodprone Area (ft.)	37	37			
Bankfull Mean Depth (ft.)	1.83	1.67			
Width/Depth Ratio	13.96	15.05			
Entrenchment Ratio	1.45	1.47			
Bankfull Width (ft.)	25.54	25.14

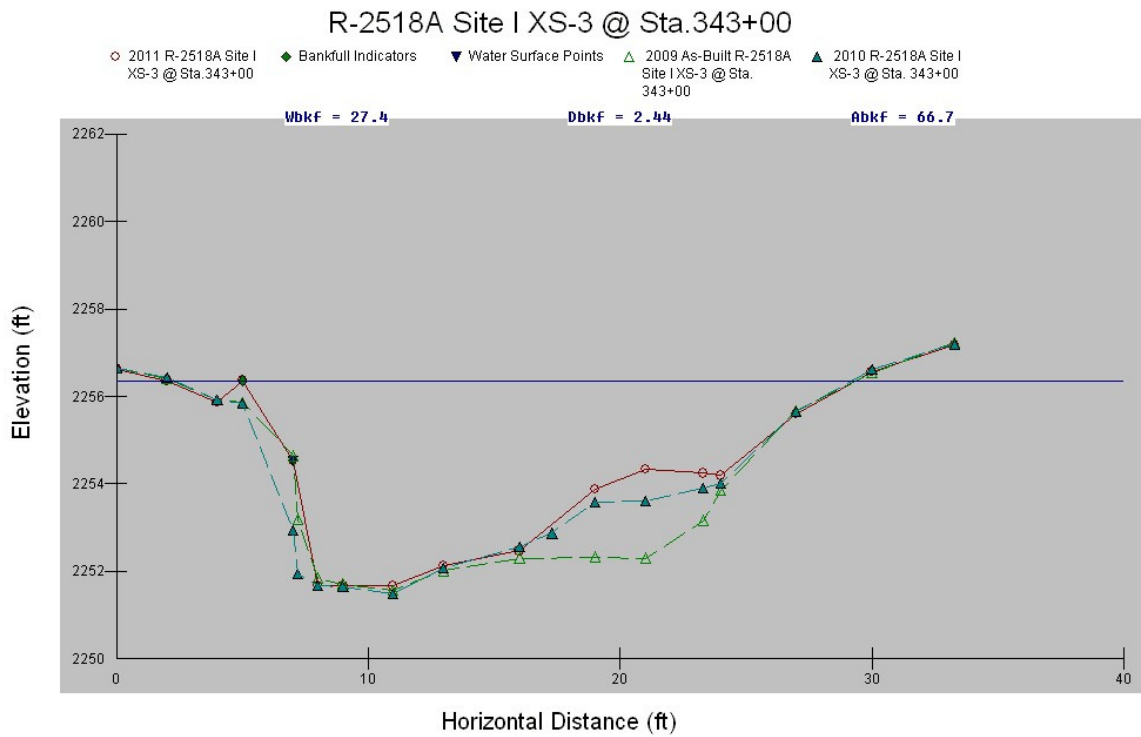
Site I: Cross-Section #3 (Pool) Abbreviated Morphological Summary					
	2010	2011	2012	2013	2014
Bankfull Cross Sectional Area (ft ²)	60.29	65.99			
Maximum Bankfull Depth (ft.)	4.35	4.7			
Bankfull Mean Depth (ft.)	2.67	2.71			
Bankfull Width (ft.)	22.59	24.38

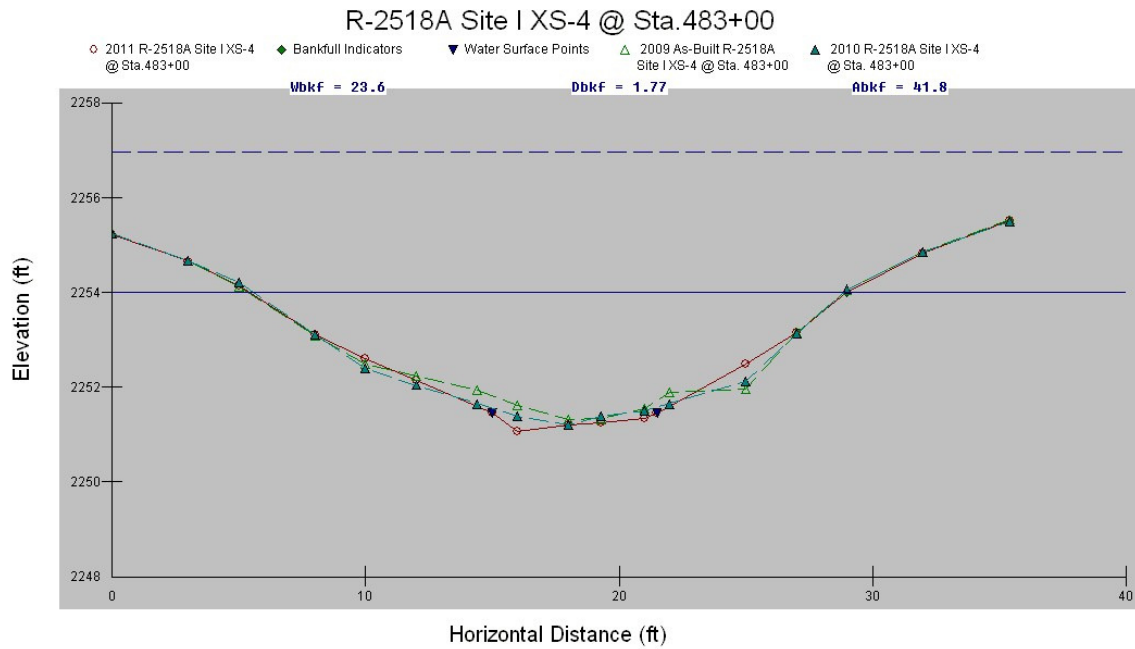
Site I: Cross-Section #4 (Riffle) Abbreviated Morphological Summary					
	2010	2011	2012	2013	2014
Bankfull Cross Sectional Area (ft ²)	43.32	41.82			
Maximum Bankfull Depth (ft.)	2.86	2.95			
Width of the Floodprone Area (ft.)	35.4	35.4			
Bankfull Mean Depth (ft.)	1.83	1.77			
Width/Depth Ratio	12.9	13.35			
Entrenchment Ratio	1.5	1.5			
Bankfull Width (ft.)	23.61	23.63

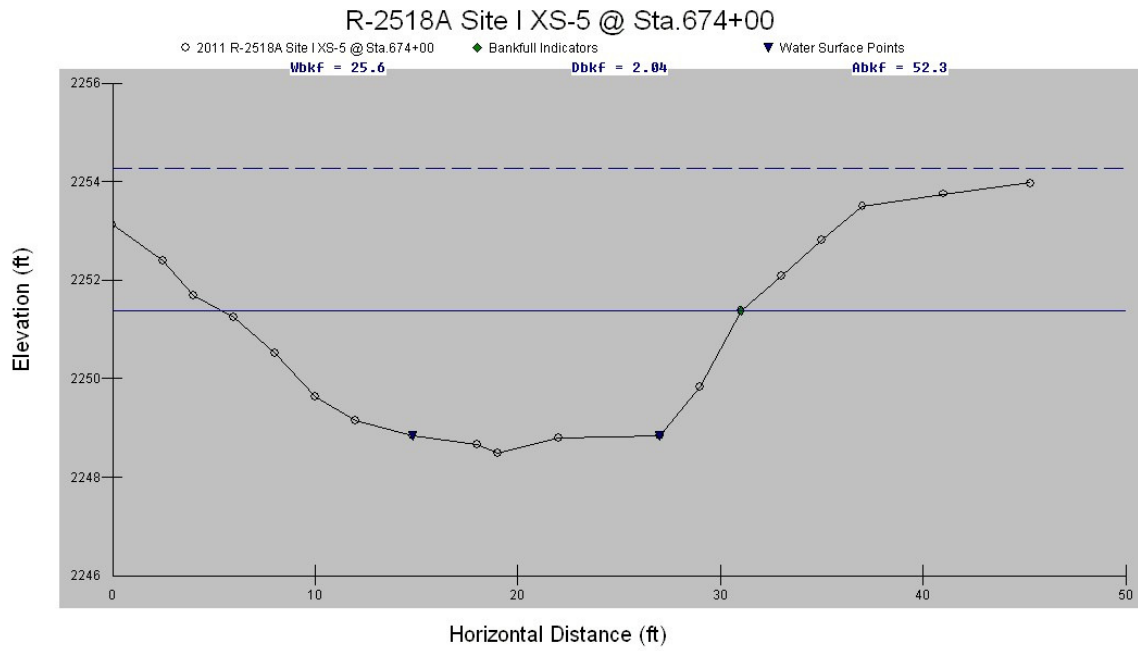
Site I: Cross-Section #5 (Riffle) Abbreviated Morphological Summary				
	2011	2012	2013	2014
Bankfull Cross Sectional Area (ft ²)	52.26			
Maximum Bankfull Depth (ft.)	2.89			
Width of the Floodprone Area (ft.)	45.3			
Bankfull Mean Depth (ft.)	2.04			
Width/Depth Ratio	12.57			
Entrenchment Ratio	1.77			
Bankfull Width (ft.)	25.64
